Madison County Public Schools

Madison Primary School Renovation Public Hearing

November 12, 2018

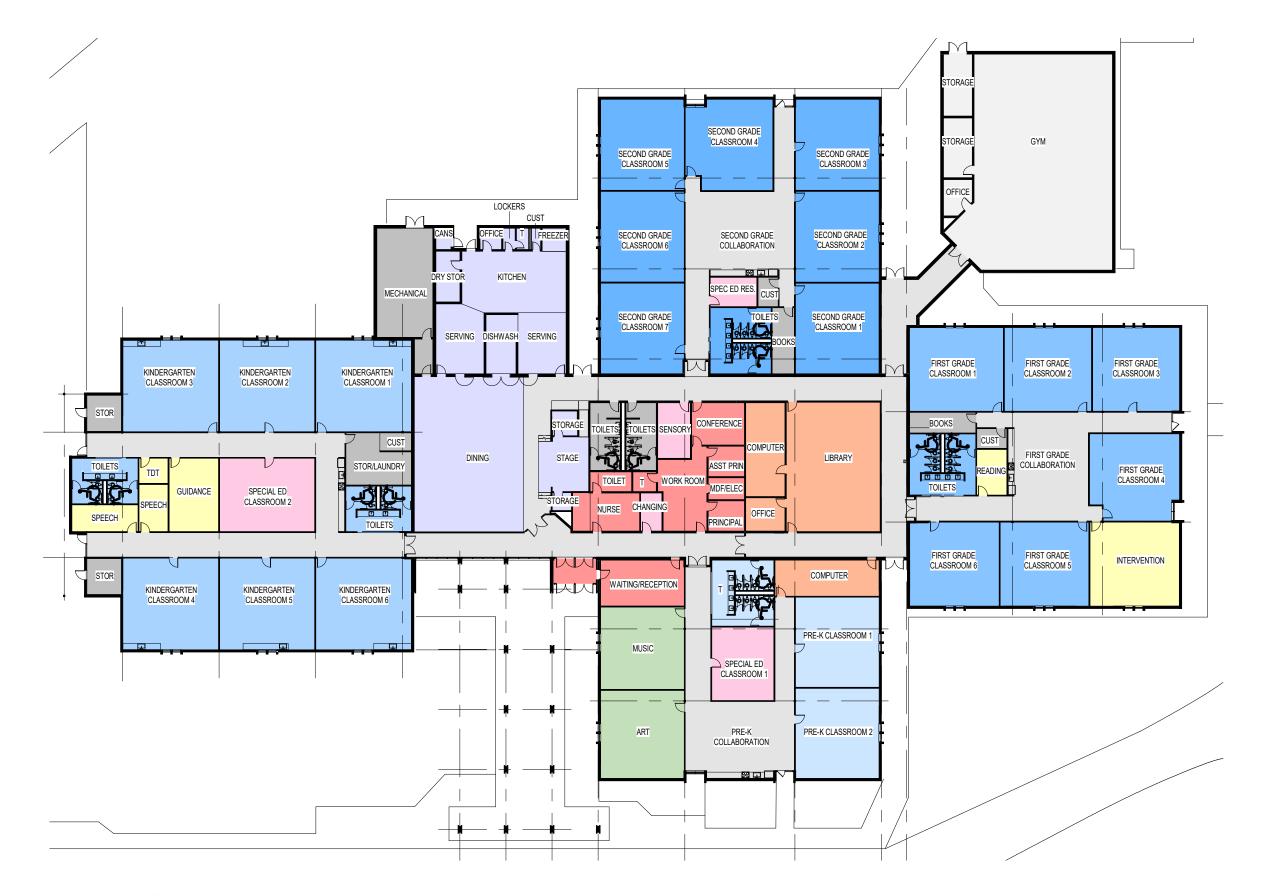
TIER 1 - RENOVATION

MADISON PRIMARY RENOVATION

1/32" = 1'-0"

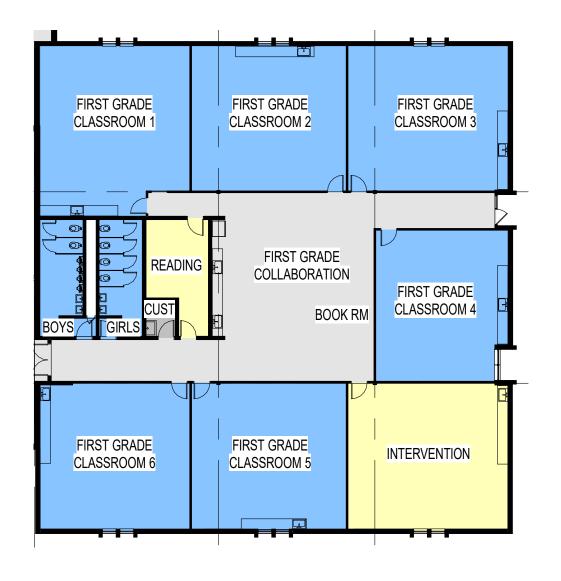
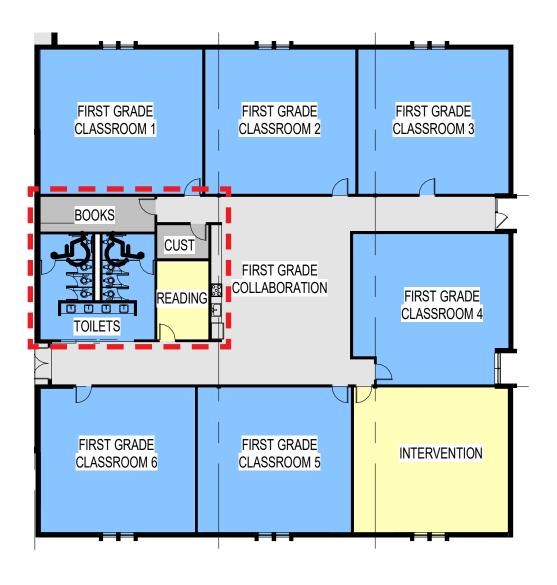
TIER 1 - FIRST GRADE POD CHANGES

EXISTING NEW

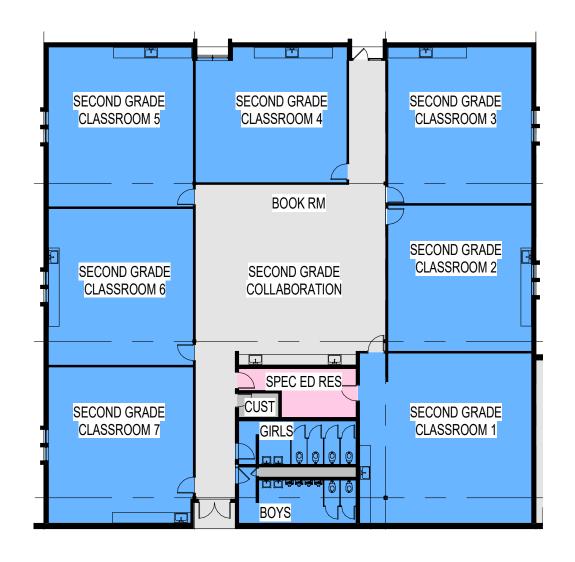
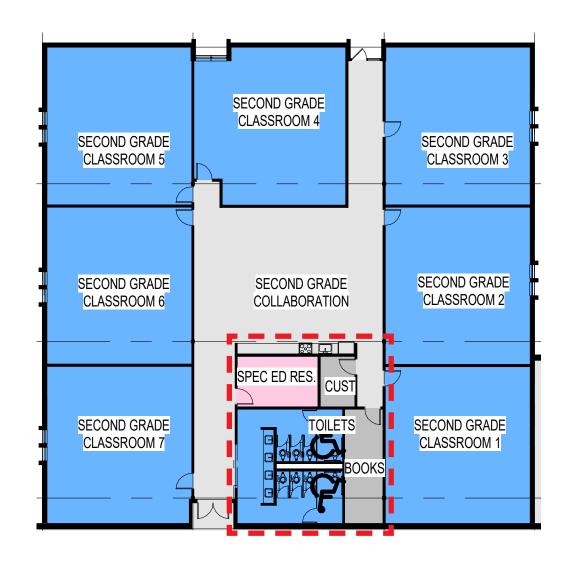
TIER 1 - SECOND GRADE POD CHANGES

EXISTING NEW

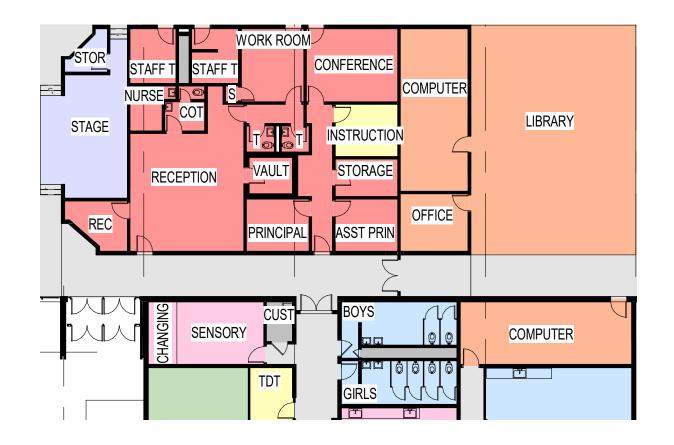
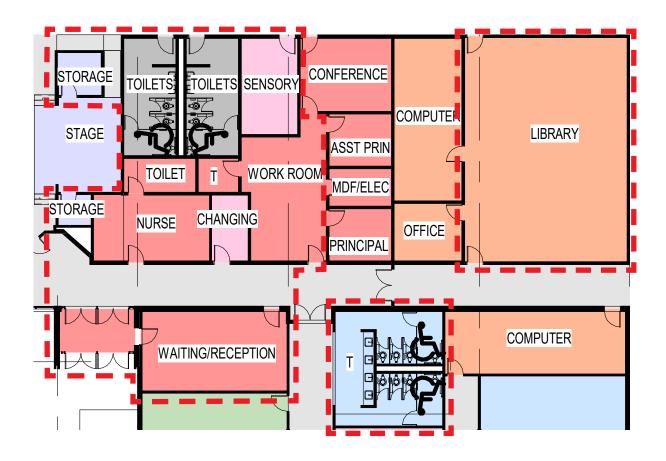
TIER 1 - CENTRAL SPACE CHANGES

EXISTING NEW

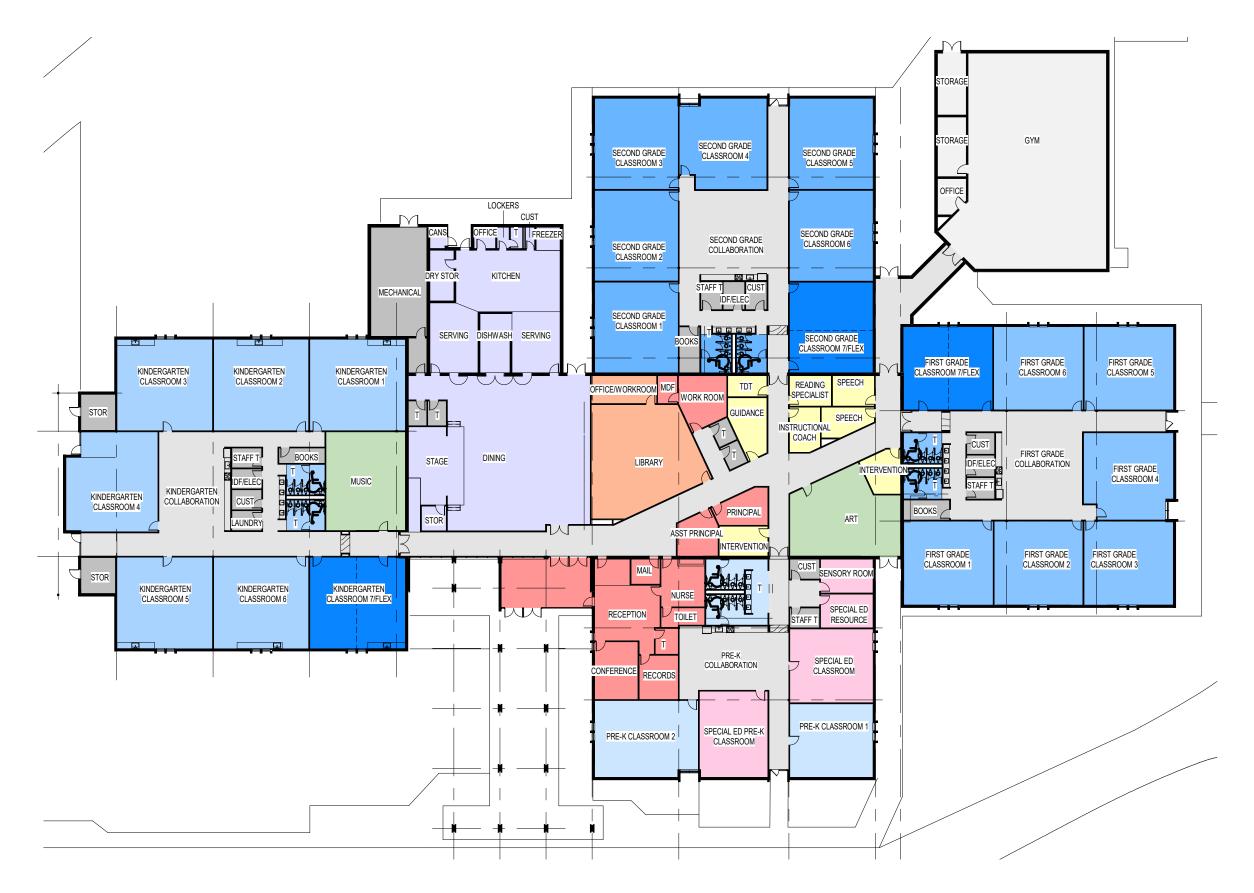
TIER 2 - FULL RENOVATION IN REWORKED LAYOUT

MADISON PRIMARY RENOVATION

1/32" = 1'-0"

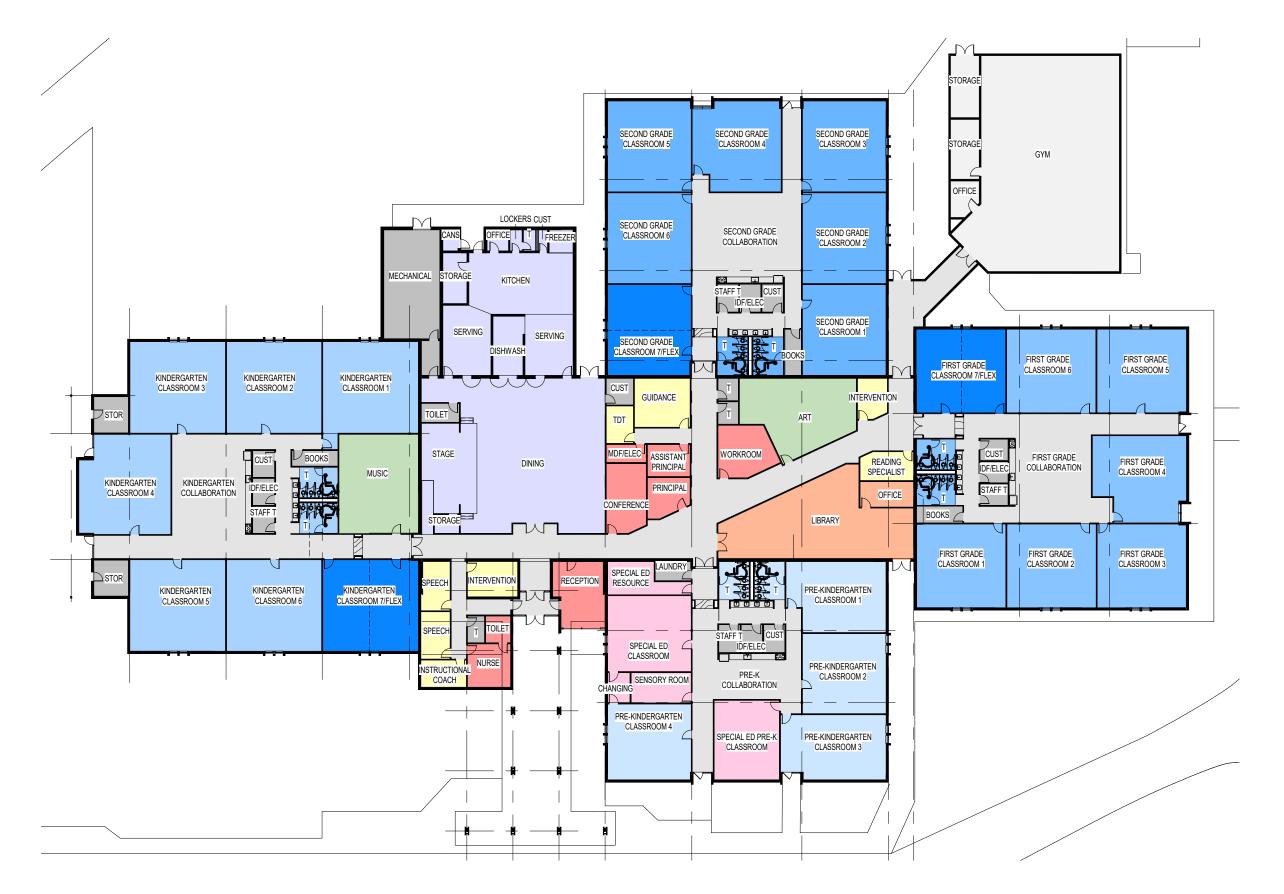
TIER 3 - FULL RENOVATION IN REWORKED LAYOUT AND 2,000 SF ADDITION

1/32" = 1'-0" **MADISON PRIMARY RENOVATION**

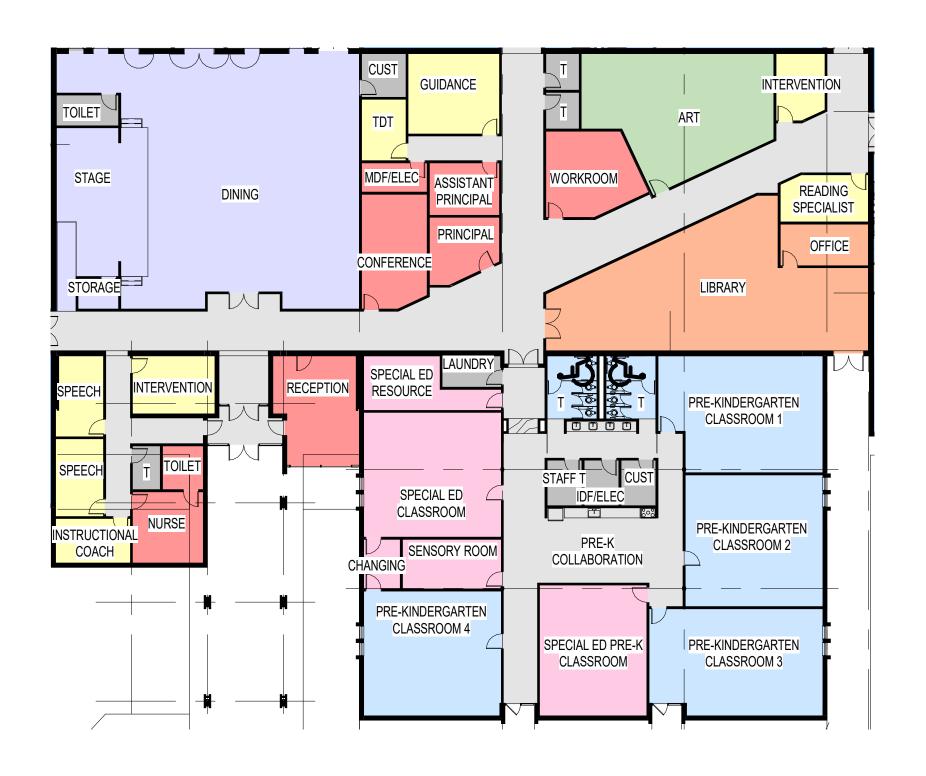
TIER 3 - CENTRAL SPACE

MADISON PRIMARY RENOVATION 1/32" = 1'-0"
